INSPECTION REPORT
FOR
TARACORP INDUSTRIES
McCOOK, ILLINOIS

ILD098983208

R05-8410-01D

SITE INSPECTION MEMO

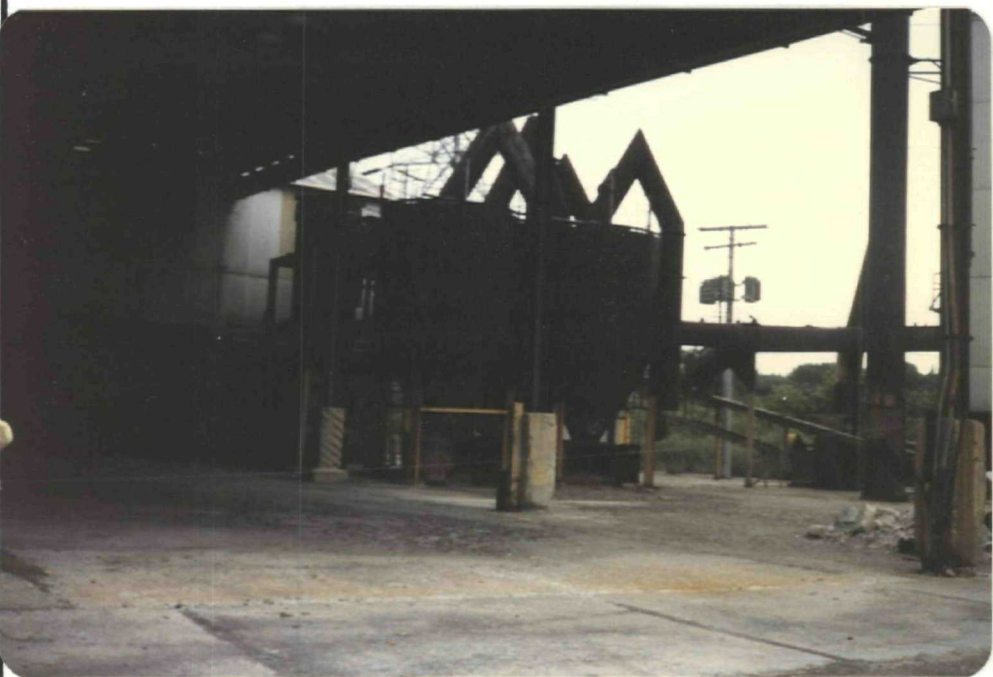
Hot gasses from the reverbatory furnace were directed through a series of cyclones and then into a baghouse. Flue dust was accumulated and screw conveyed back to the reverbatory furnace.

NADESCRIPTION: Cyclones adjacent to Former Hazardous
Storage Shed Area

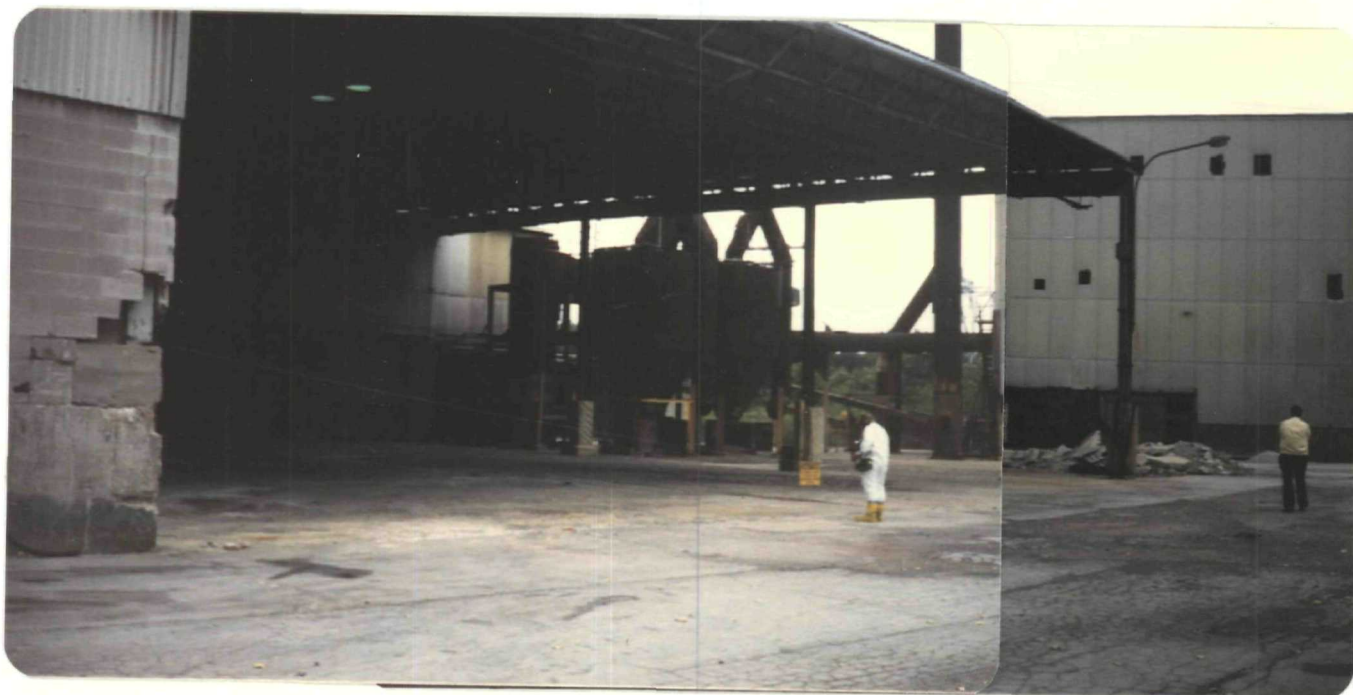
DESCRIPTION: View of Former Hazardous Storage Shed Area with adjacent
Cyclones and Main Metallurgical Baghouse Building (far right)

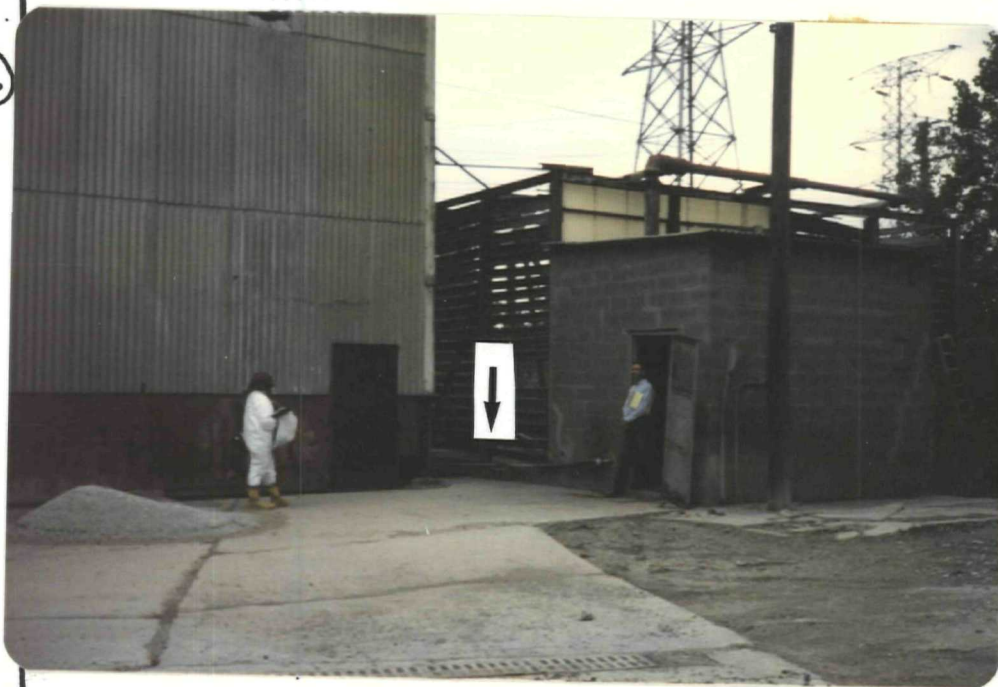
DESCRIPTION: Location of Cooling Tower Basin (indicated by arrow)
adjacent to Main Metallurgical BaghouseDATE 9/9/86TIME 2:58 A.M. P.M.DIRECTION: N NNE NE ENE
E ESE SE SSE
S SSW (SW) WSW
W WNW NW NNWWEATHER mid 60°s F,
cloudySITE Taracorp IndustriesTDD# ROS-8410-01D

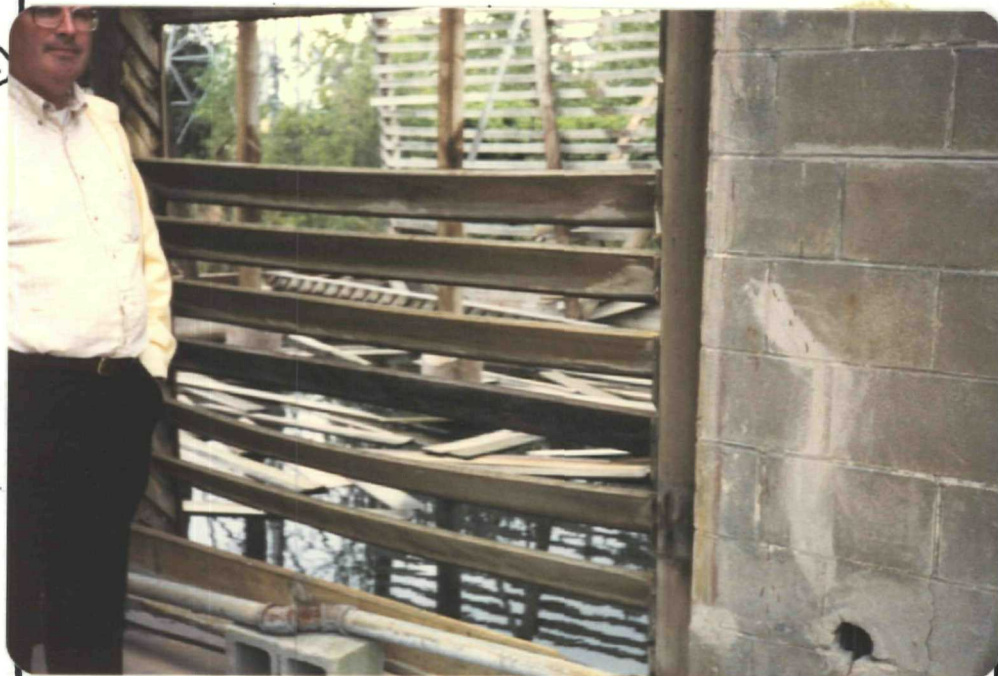
DESCRIPTION: Close-up of Cooling Tower Basin

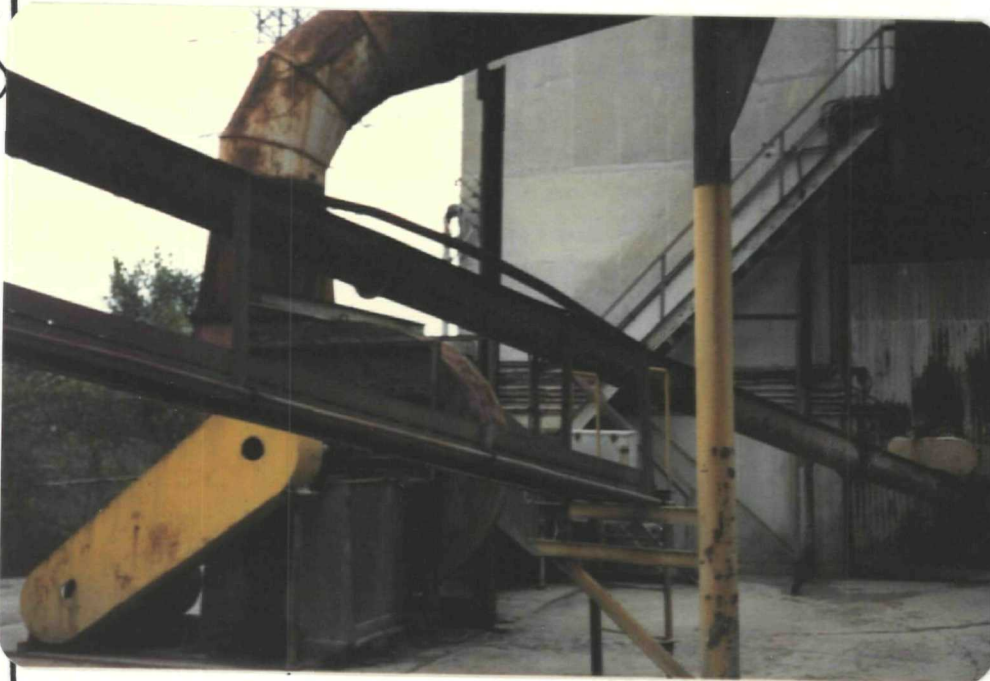
According to George Webb, Taracorp Industries, flue dust was considered a feedstock and not a waste as it was internally recycled via the screw conveyor. No flue dust was allegedly disposed of on-site.

Cynthia PughSAMPLE ID# (if applicable)
NADESCRIPTION: Screw Conveyor

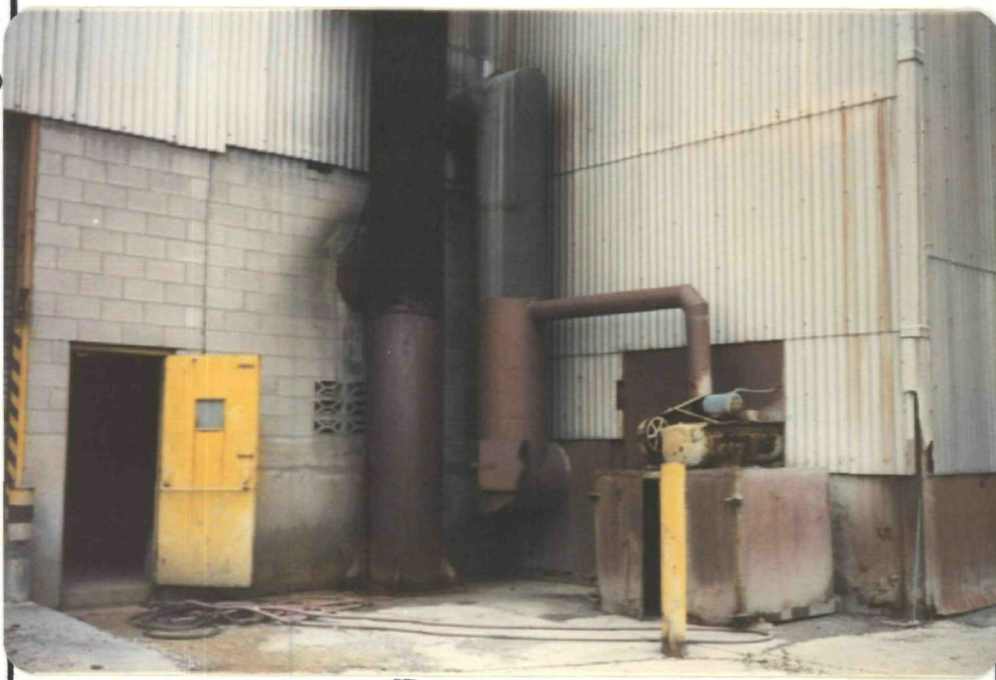
The pot furnaces generated very little dust. Any dust that was generated was collected in a baghouse. The pot furnaces were directed into the main (reverbatory) metallurgical baghouse prior to 1980-1981. After that time, the pot furnaces were directed into a separate baghouse. Baghouse dust from the pot furnaces was collected in front-end loaders and then transported to the reverbatory furnace for recycling.

DESCRIPTION: Location of Sanitary Baghouse for Pot Furnaces
